South Carolina
Department of Transportation

Field Evaluation of Temperature Differential in HMA Mixtures

May 2012

Report No. FHWA-SC-12-02

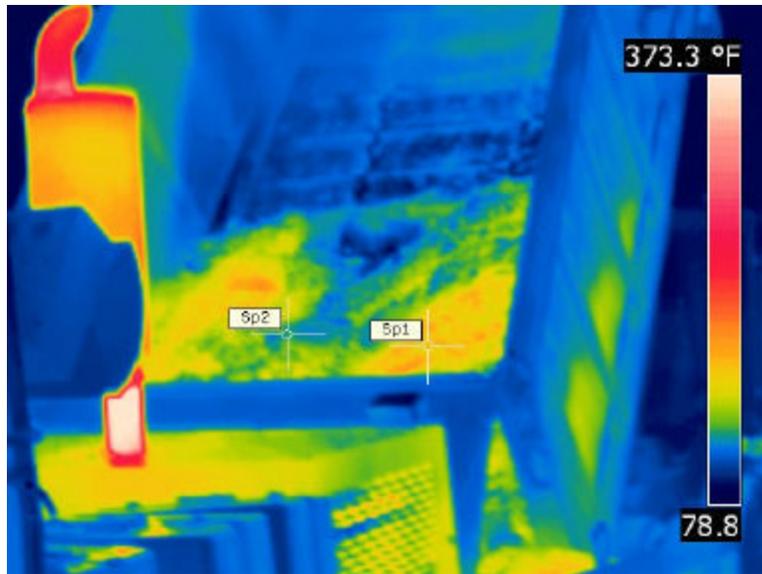
Figure 1: Example thermal image of (A) an asphalt truck backed up to paver with mix still in the bed and (B) thermal segregation in mat behind the paver before compaction.

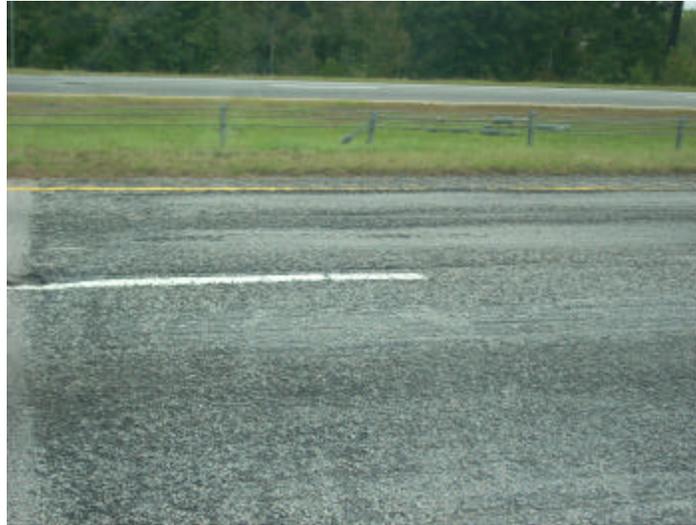
Figure 3: Severe Raveling at OGFC Construction Joint on I-26 Eastbound

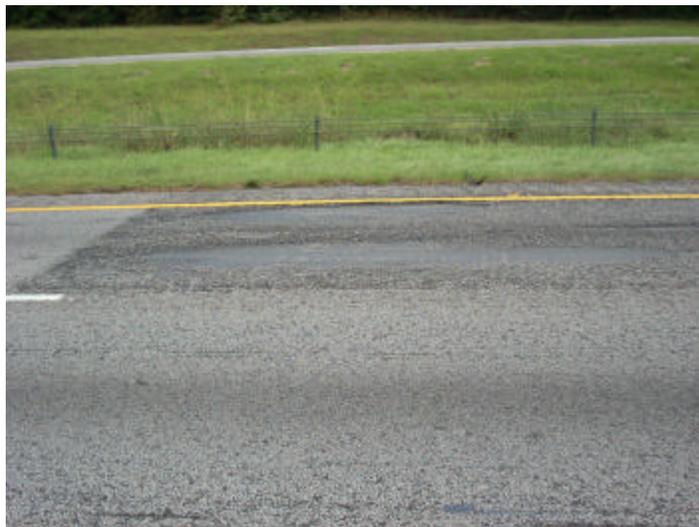
Figure 4: Severe Raveling at OGFC Construction Joint on I-26 Eastbound

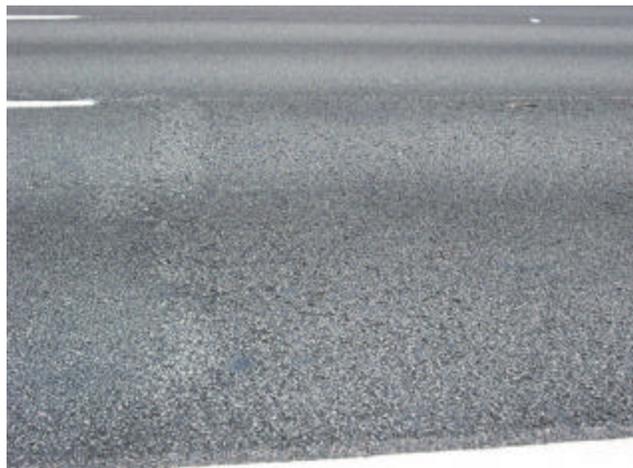
Appendix H shows the progression of the temperature differential damage of the segment shown in figures 5 (A) and (B) and 6 (A) and (B). The main mechanism of failure in these pictures is the raveling of the OGFC. As can be seen in the pictures, distress was evident at six months. At 36 months, a major hole had developed in the pavement surface, which only got worse as the pavement aged.

Figure 6 (A): OGFC Construction Joint Cold Spot After Six Months Service
(OGFC on I-77 in Richland County)

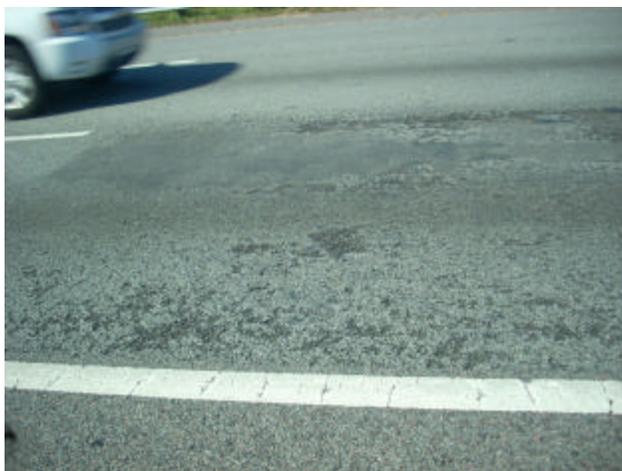
Figure 6 (B): OGFC Construction Joint Cold Spot After 48 Months Service
(OGFC on I-77 in Richland County)

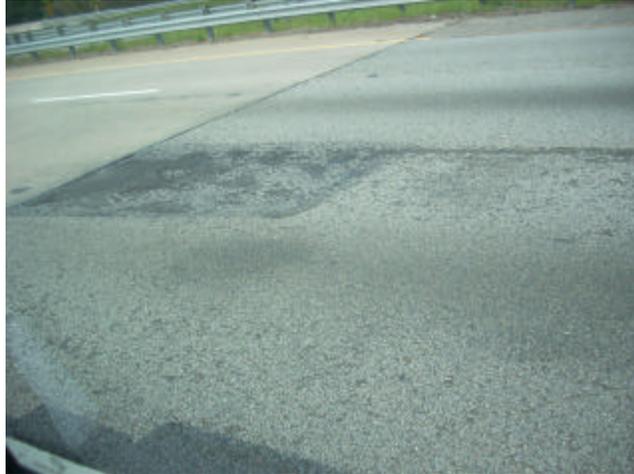
This location showed slight raveling at only six months; however significant raveling was present at 18 months. After 42 months of service, a hole had developed. The distress is not as severe as the distress at the previously discussed construction joint, but is still causing serious roughness and a location for water to pond. Appendix I shows pictures of the segment over the time of the investigation.

Figure 8: OGFC Bridge Departure Cold Spot After 42 Months in Service

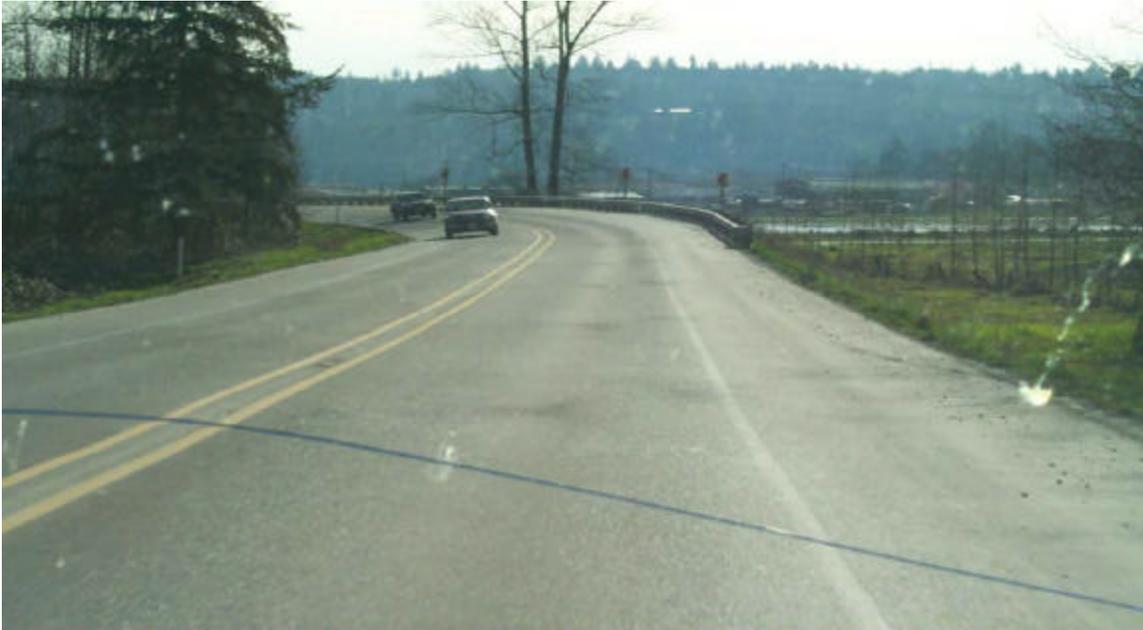
differential damage would be more likely in these areas. No cyclical textural changes corresponding to thermal segregation were evident at the time of this report. This could explain some of the lack of temperature differential damage.

Figure 10: Cyclical Pavement Mat Texture Changes Due to Thermal Segregation
Washington Department of Transportation (n.d.)

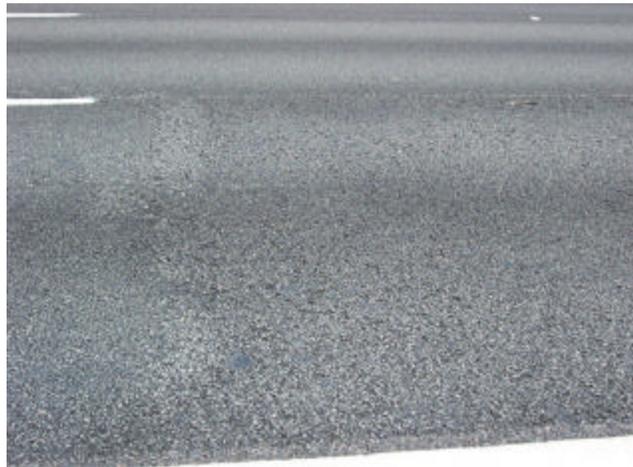
OGFC Construction Joint Cold Area After Six Months

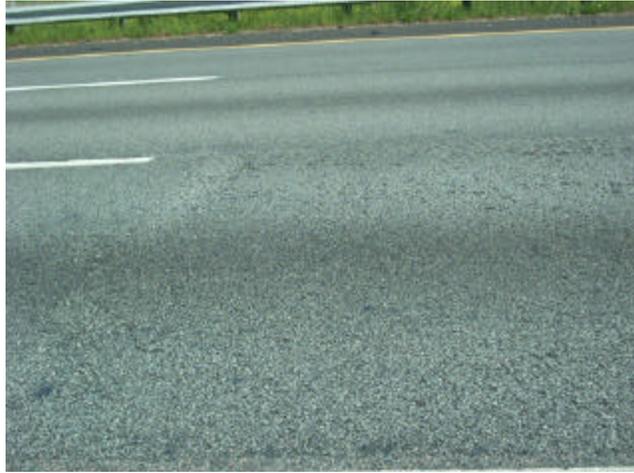
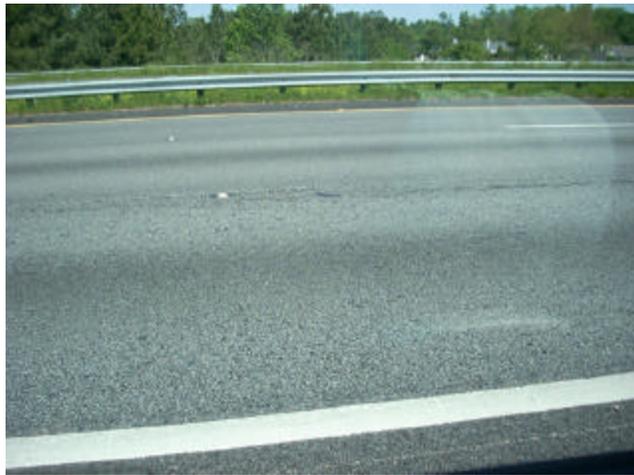
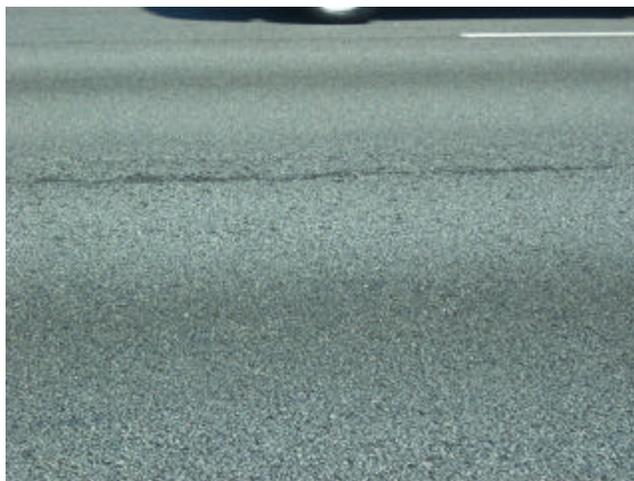
OGFC Construction Joint Cold Area After 12 Months

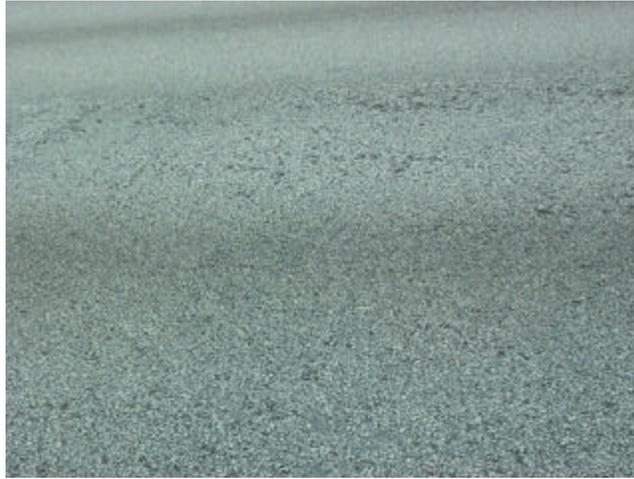
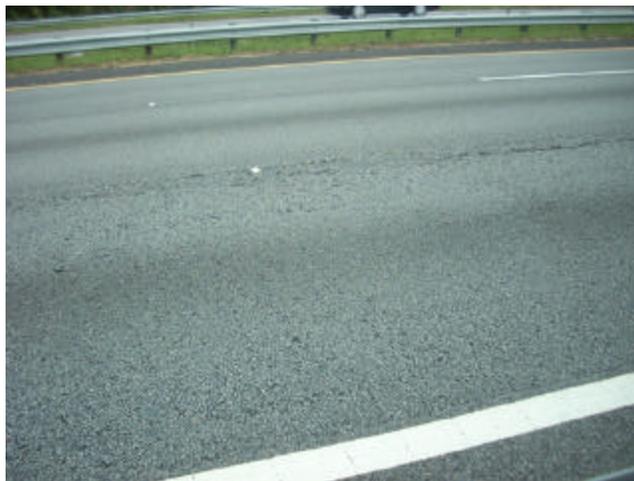
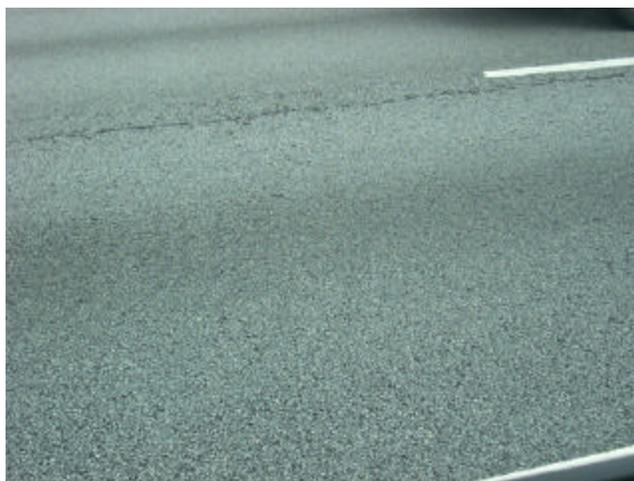
OGFC Construction Joint Cold Area After 18 Months

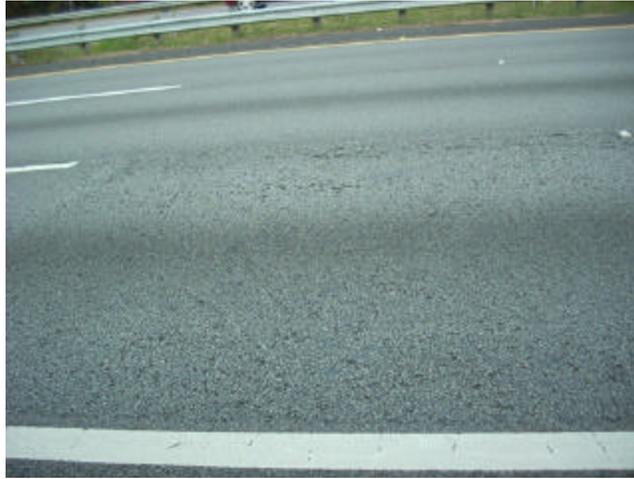
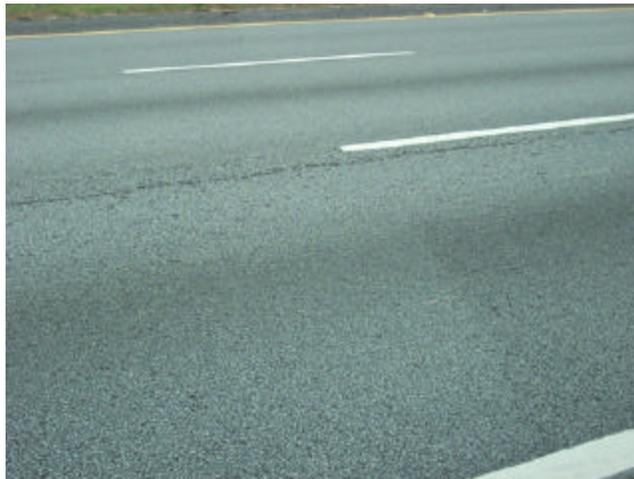
OGFC Construction Joint Cold Area After 24 Months

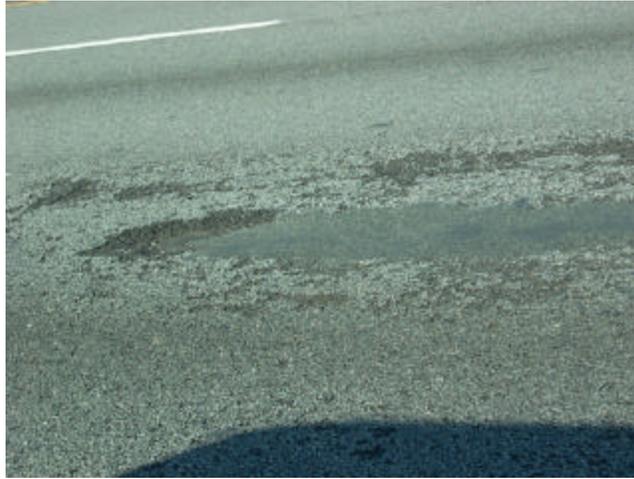
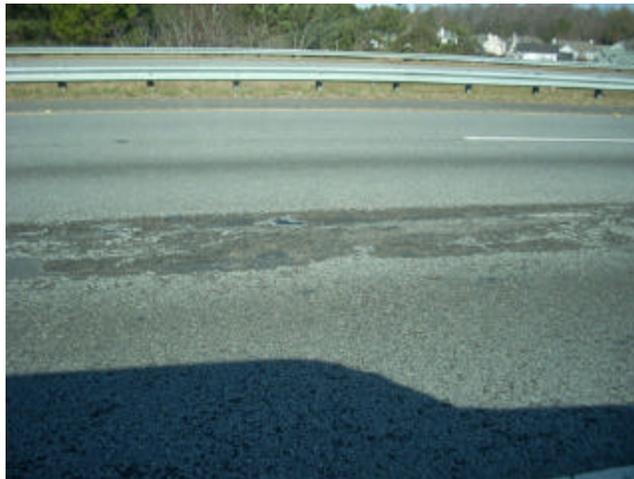
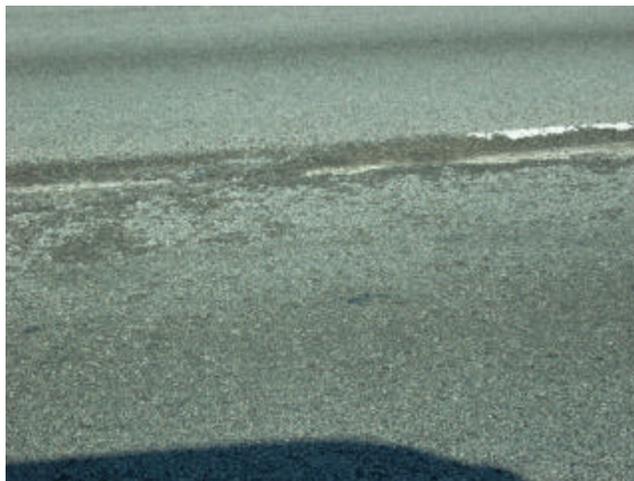
OGFC Construction Joint Cold Area After 36 Months

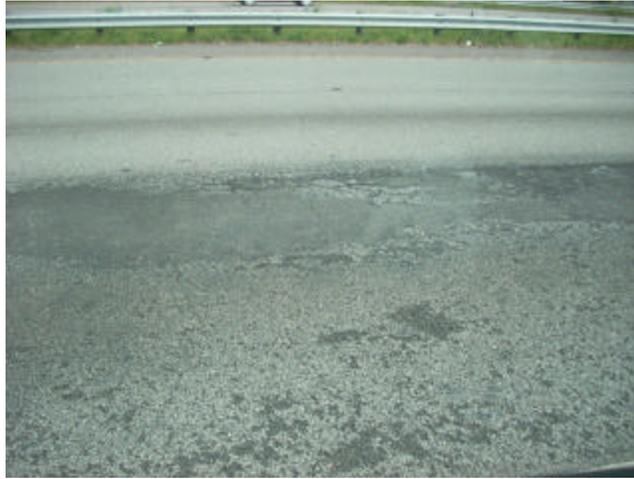
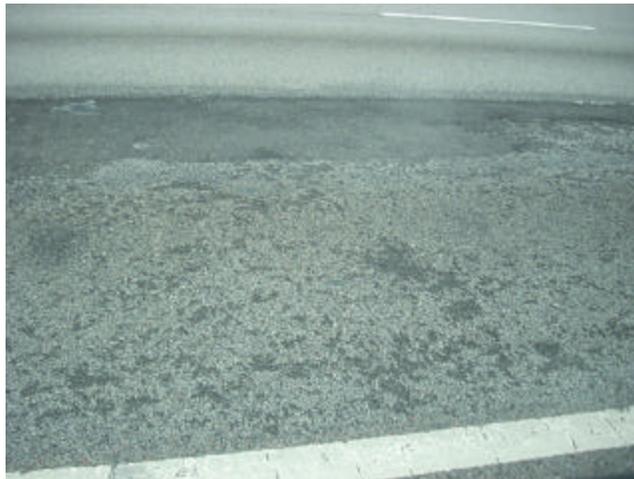
OGFC Construction Joint Cold Area After 42 Months

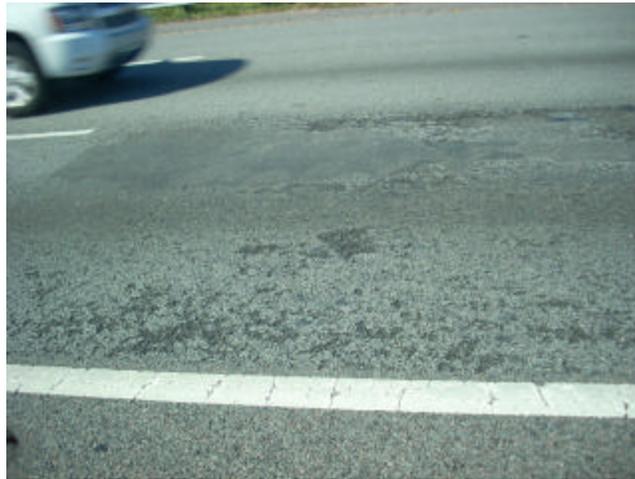
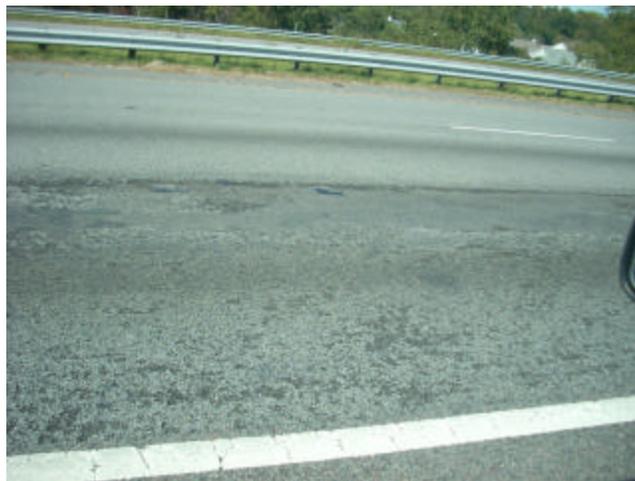
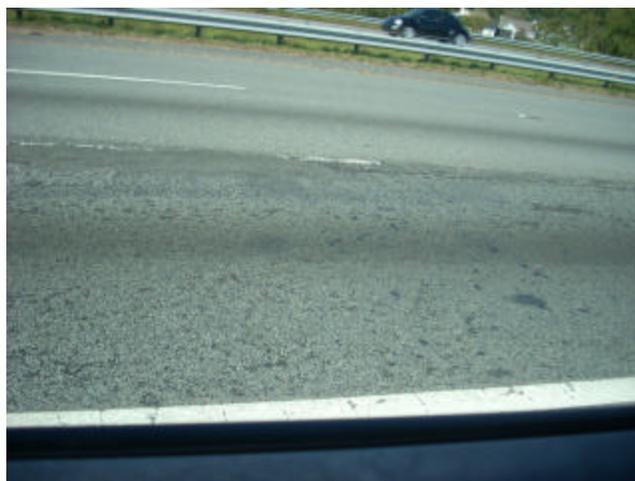
OGFC Construction Joint Cold Area After 48 Months

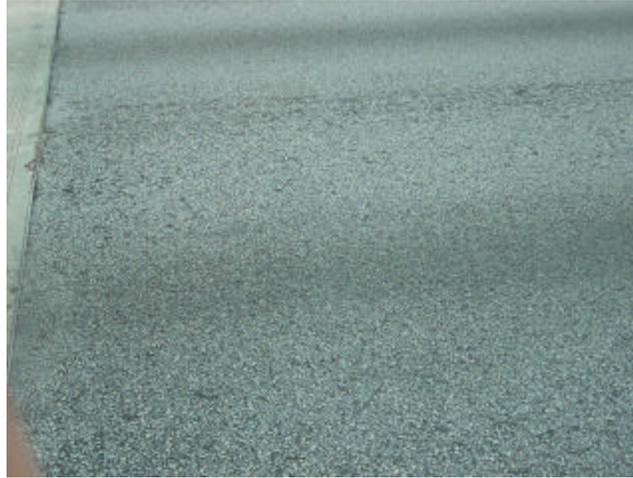
OGFC Bridge Departure Cold Area After 18 months.

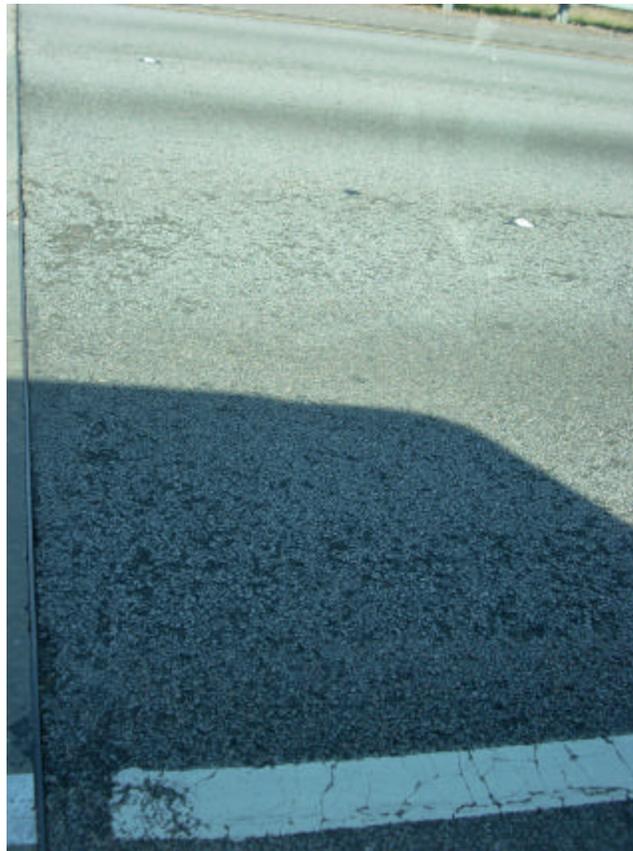
OGFC Bridge Departure Cold Area After 36 Months

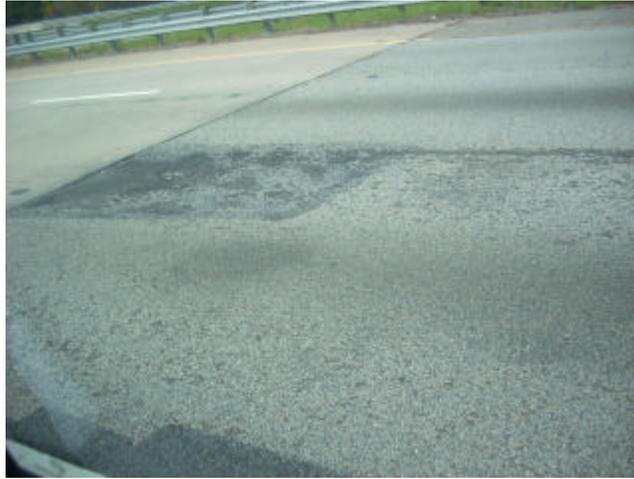
OGFG Bridge Departure Cold Area After 42 Months

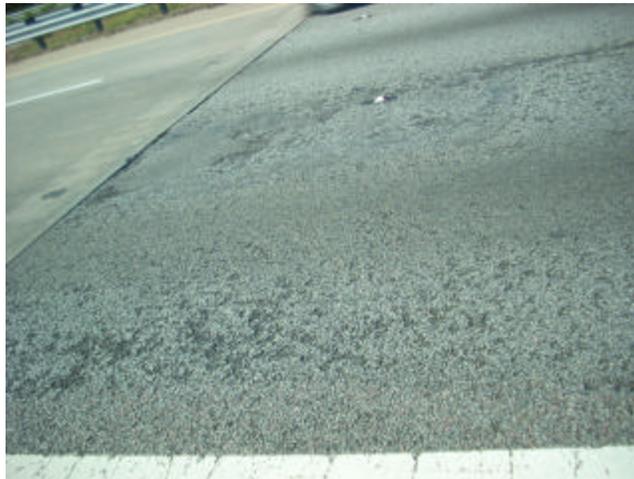
OGFC Bridge Departure Cold Area After 48 Months
